SURGE SUPPRESSION INCORPORATED

POWER QUALITY STUDY

February 10, 2016, Tom Butcher from Technology Services, Surge Suppression Incorporated, joined [] , North American Sales Manager – Mining & Energy from [] Company, Inc. We met with [] , Electrical Supervisor, [] Dragline Operations, at the [] mining operations office in [] , to conduct a power quality study of three of their mine's dragline equipment.

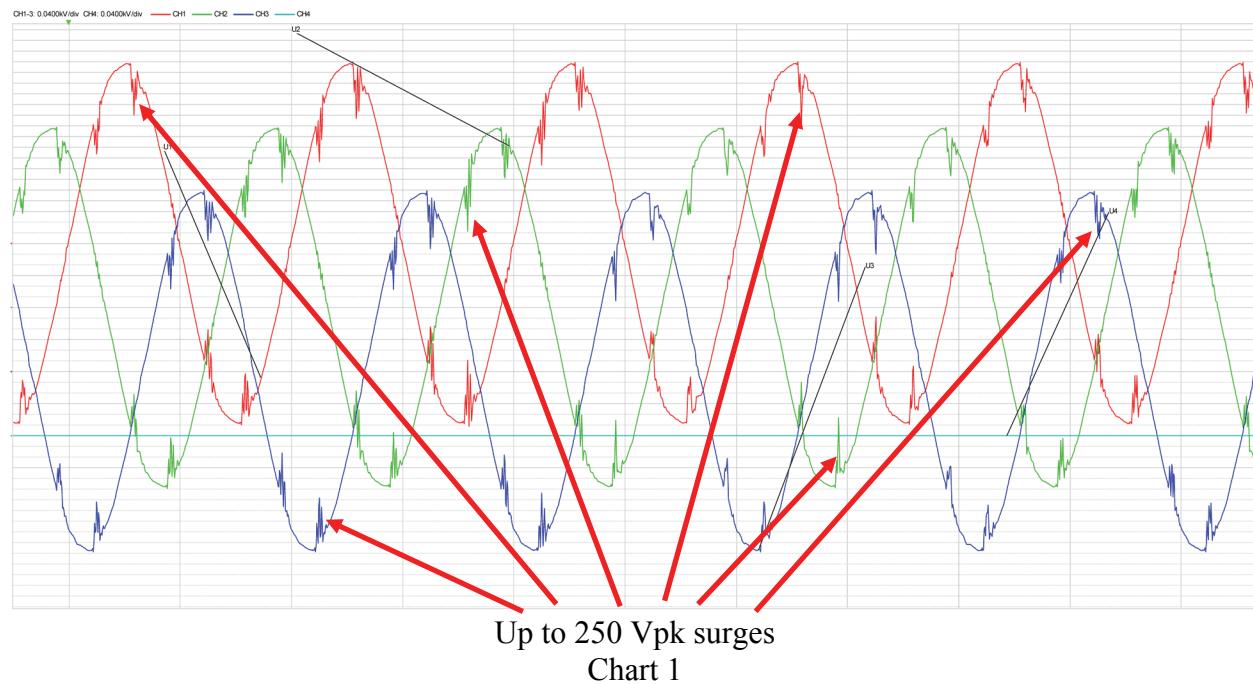
The red waveform is Phase A to Phase B voltage events near the end of the monitoring period. The green waveform is Phase B to Phase C voltage events near the end of the monitoring period. The blue waveform is the Phase C to Phase A voltage events near the end of the monitoring period. Normal voltage variations and multiple transient surge activity ranging from a positive 200+ Volts peak (V_{pk}) to a negative 200+ V_{pk} .

The voltage surges on all three phase combinations (A to B, B to C, and C to A) are occurring several times per cycle. They are not catastrophic, but they do have the potential to cause cumulative damage over time. They are occurring four times per cycle, every cycle, equaling 864,000 times per hour. This level of surge activity will create “hot spots” within the LED drivers and lights. With the rapid repetition of the surges, the “hot spots” will never cool down and the accumulating heat will accelerate deterioration of the components, causing early failure of the drivers and lights.

A properly sized surge protective device, installed on the lighting panel with leads as short and straight as possible, will provide a path off the electrical system for these surges and remove their damaging effect on the drivers and LED lights.

The Marion 8200 Unit 14 dragline at the mine should have a CDLB3N4-D3, 480 V_{rms}, 3 Phase, 3 Wire, Delta, 60 kA per mode SPD with NEMA 4X enclosure and rotary disconnect installed on the LED lighting panel.

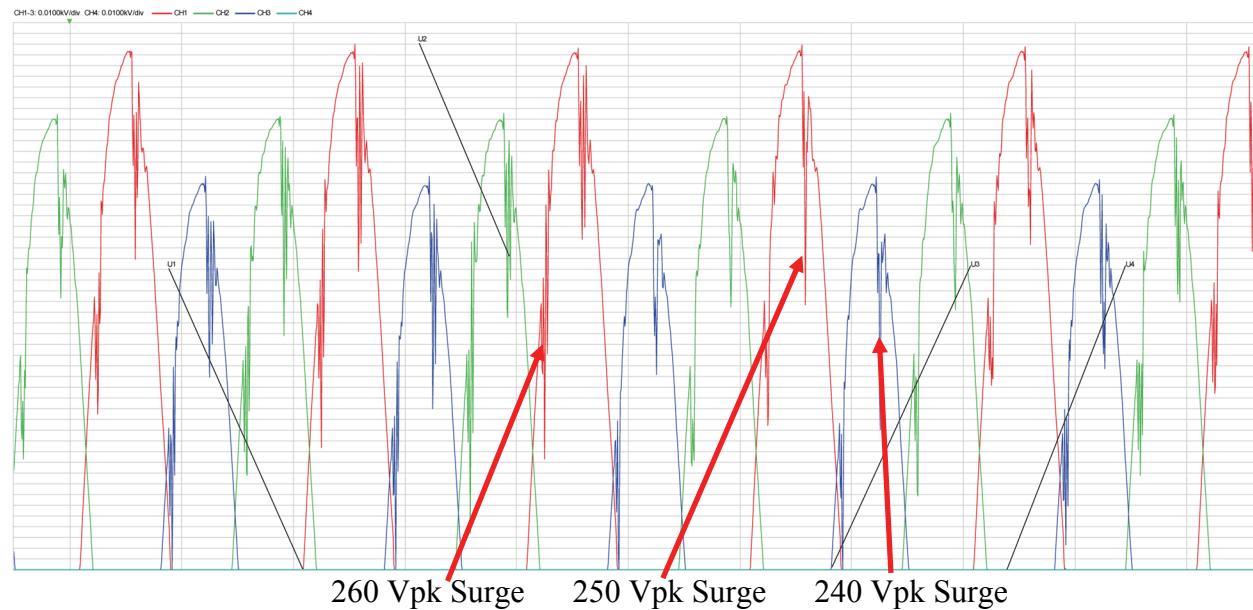
Chart 2 shows an expanded version of the voltage waveform with the surge activity at several points on the waveform.

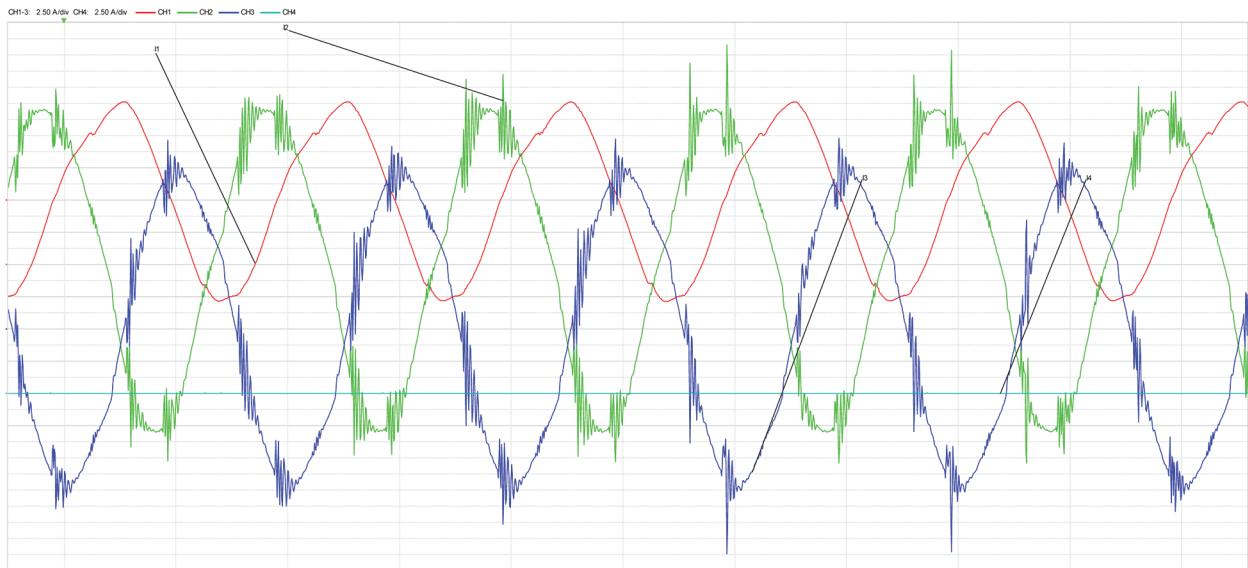
Chart 3 shows the current waveform for the same event. Phase A current is 10.6 Arms, with slight distortion and no surges. Phase B and Phase C are both 17.7 Arms, with multiple surges of 17 Apk or more, in four groups on each cycle of both phases.
